**Flood Control Project Maintenance
Levee Inspections**

Fall 2016 Levee Maintenance Deficiency Summary Report

Reclamation District No. 1500 Sutter Basin

Fall 2016 Levee Inspection Results

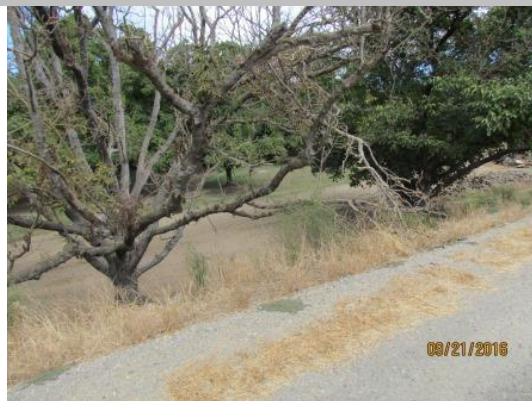
Photo 1 of 1 : FA_2016_RD1500_189_137_20160926_00274.jpg

A tree on landside slope needs trimming. Fall 2016.

LM Start	0.19	Rating **	C	Issue No.	126
LM End	0.19	Issue Type +	Ma	Location *	LS
Category	Earthen Levee			GPS Latitude/Longitude	
				Start	End
Item	Trim / Thin Trees			38.761650 °	38.761650 °
				-121.677950 °	-121.677950 °
DWR ID	DWR_RD1500_01_s_2016_126				
Comment Code					
T1 : Trim trees to at least five feet above ground level.					
Inspector Comment					
Tree branches are broken and on the levee slope.

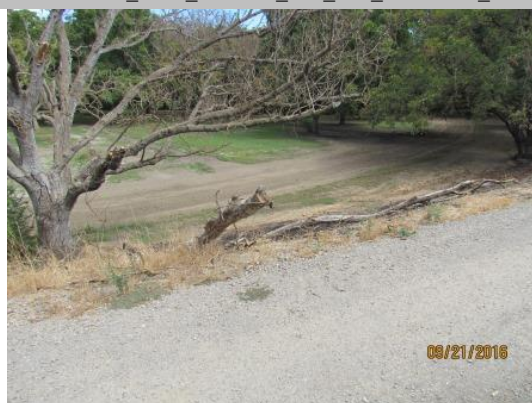
Photo 1 of 1 : FA_2016_RD1500_189_136_20160926_00273.jpg

Prunings on landside slope. Fall 2016.

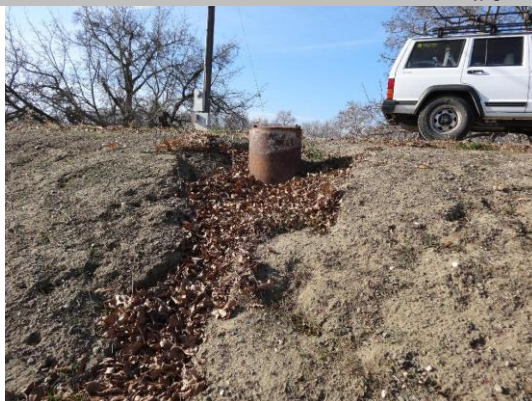
Photo 2 of 2 : UCIP_FA_2016_28263_51964.jpg

LS view: siphon breaker in CMP riser. Levee slope erosion due to leaky siphon breaker.

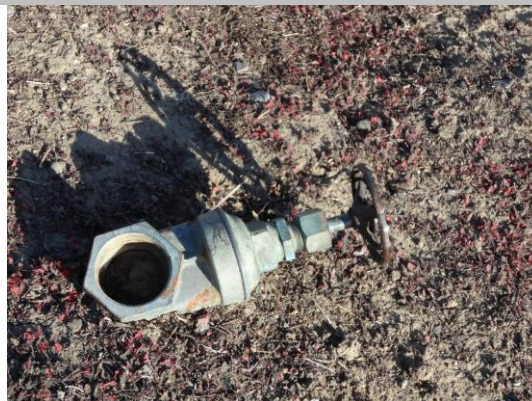
Photo 2 of 2 : UCIP_FA_2016_28272_52011.jpg

LS view: pressure breaker without protection on levee slope.

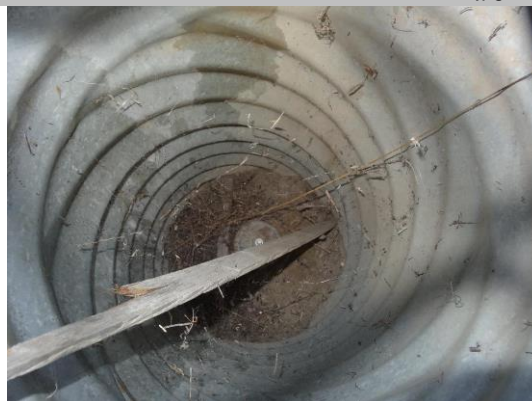
Photo 2 of 2 : UCIP_FA_2016_28912_53180.jpg

LS view: obstructed siphon breaker in CMP riser.

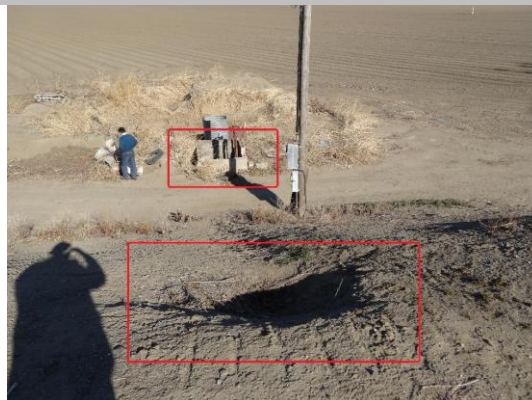
Photo 2 of 2 : UCIP_FA_2016_28913_53183.jpg

LS view: depression on landside levee slope around siphon breaker due to leakage. Concrete distribution box (top) on levee toe.

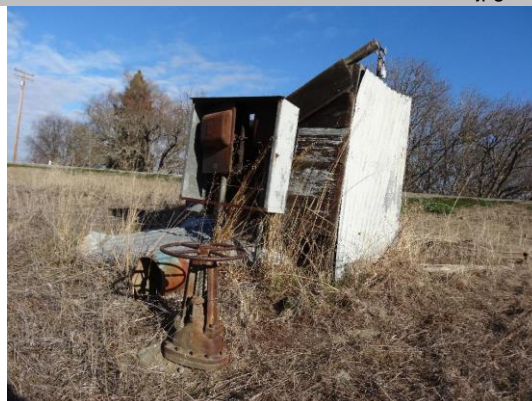
Photo 1 of 2 : UCIP_FA_2016_28923_53202.jpg

WS view: dilapidated and abandoned CM pump house on berm. Pipe and gate valve also on berm.

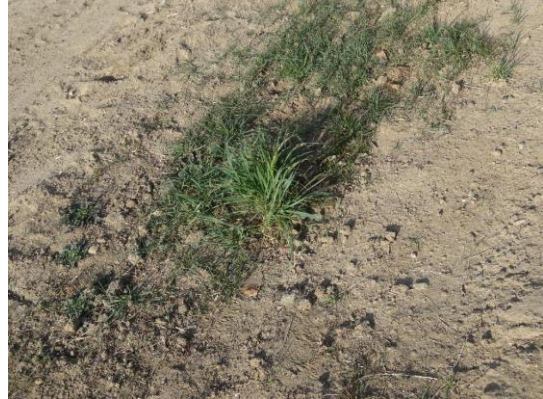
Photo 2 of 2 : UCIP_FA_2016_50199_53203.jpg

WS view: sign of leakage- excessive vegetation on levee slope.

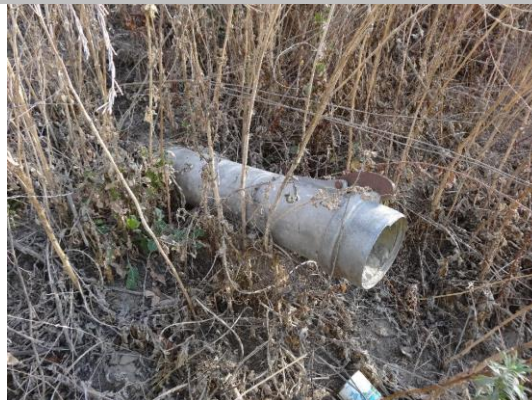
Photo 2 of 2 : UCIP_FA_2016_28323_52124.jpg

WS view: abandoned steel pipe exposed on river bank.

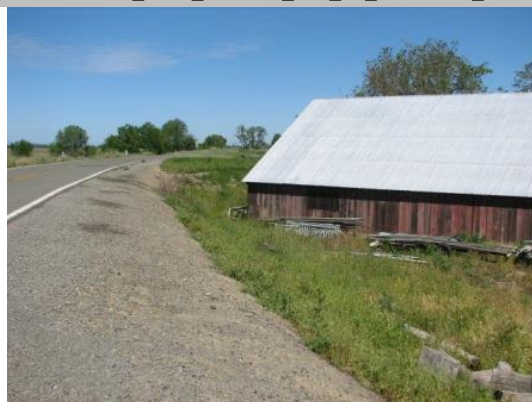
Photo 1 of 1 : FA_2016_RD1500_189_18_20160913_00016.jpg

The corner of the building has encroached into the toe.

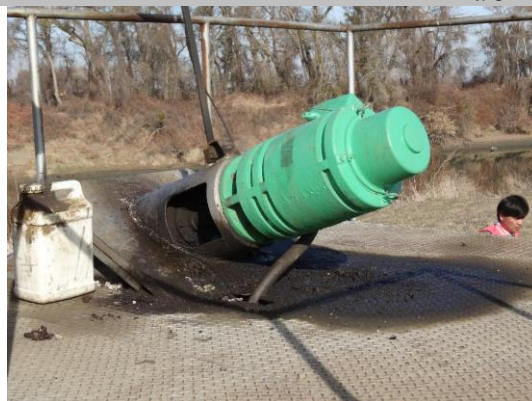
Photo 1 of 2 : UCIP_FA_2016_28364_52174.jpg

WS view: slant pump on steel platform on levee berm. Excessive oil leak from the pump.

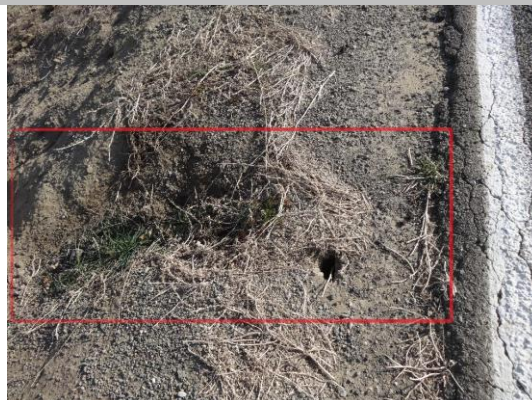
Photo 2 of 2 : UCIP_FA_2016_50043_52212.jpg

LS view: wet, some vegetations, and subsidence along pipe alignment on landside.

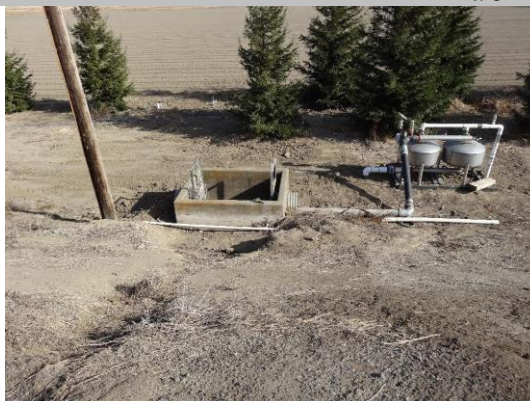
Photo 2 of 2 : UCIP_FA_2016_50198_52219.jpg

LS view: depressions along the pipe alignment on levee slope. It needs detailed investigation.

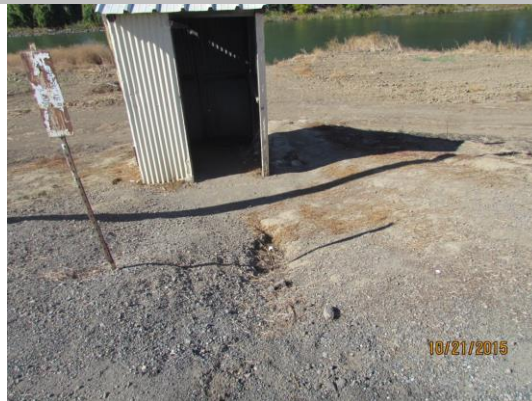
Photo 3 of 3 : FA_2016_RD1500_189_114_20160913_00060.jpg

There is slight erosion on the waterward side of the levee where the pipe seems to run through the levee. Fall 2015.

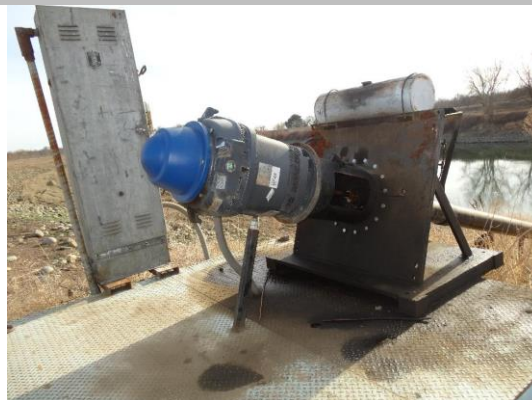
Photo 2 of 2 : UCIP_FA_2016_28486_52460.jpg

WS view: oil leaking slant pump on steel platform.

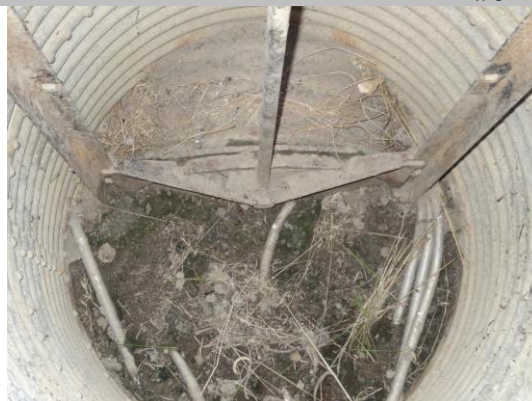
Photo 2 of 2 : UCIP_FA_2016_28489_52478.jpg

WS view: cleaning and clearing require around slide gate in CMP riser.

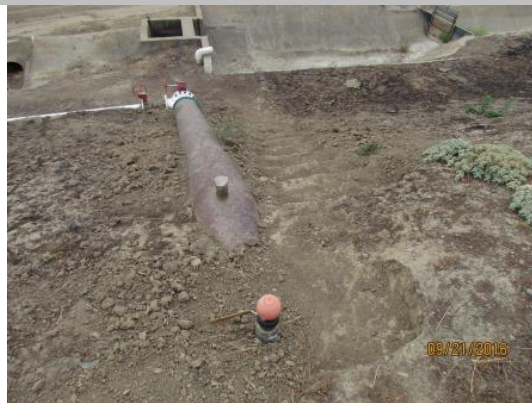
Photo 1 of 1 : FA_2016_RD1500_189_117_20160926_00260.jpg

View of stairs dug on landside levee slope. Fall 2016.

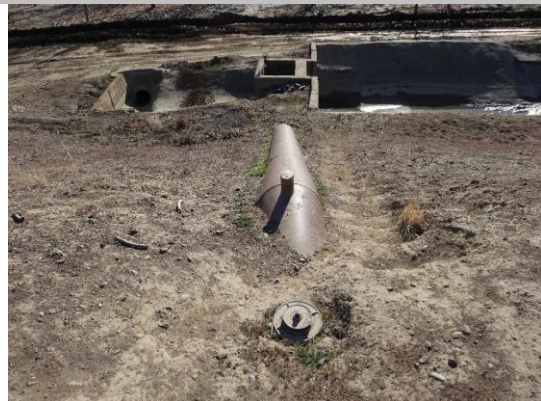
Photo 2 of 2 : UCIP_FA_2016_28490_52484.jpg

LS view: siphon breaker (bottom) without protection, exposed pipe on levee slope, and distribution box on levee toe.

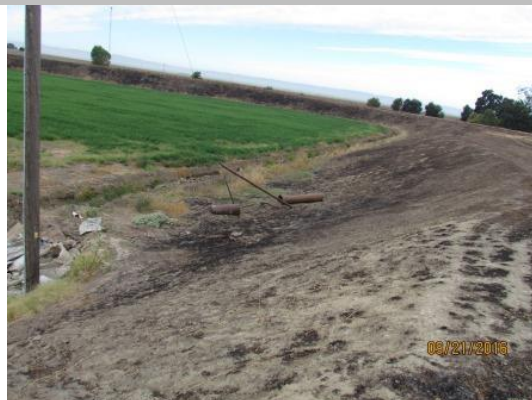
Photo 1 of 1 : FA_2016_RD1500_189_113_20160926_00259.jpg

Debris on landside slope of the levee. Fall 2016.

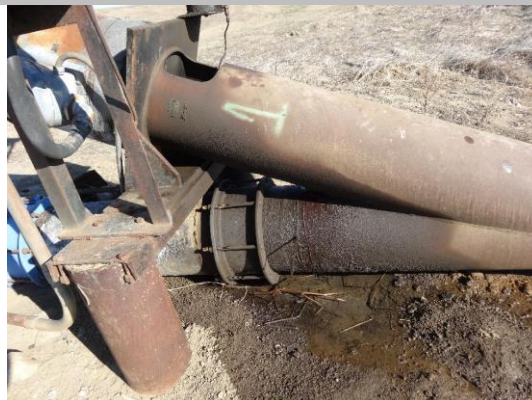
Photo 2 of 2 : UCIP_FA_2016_28528_52575.jpg

WS view: leaky inlet pipe near pump platform.

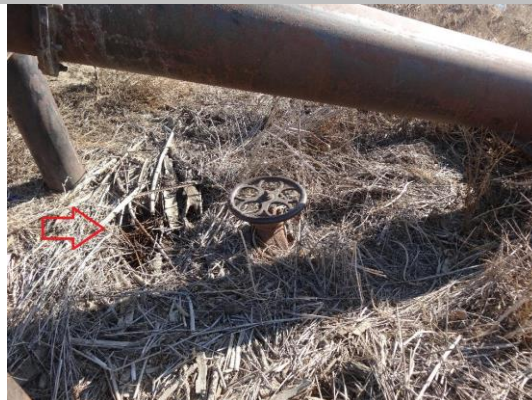
Photo 2 of 2 : UCIP_FA_2016_28583_52626.jpg

WS view: gate valve beneath slant pipe on levee berm. Water leaking from this pipe (marked).

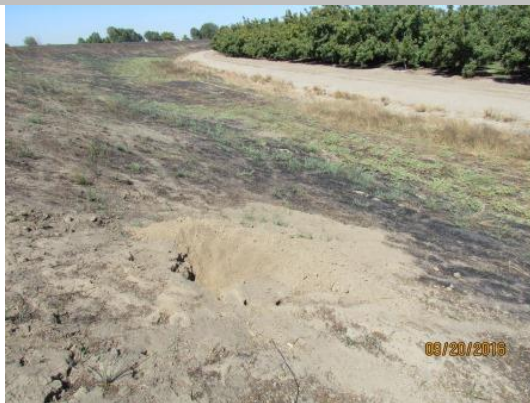
Photo 1 of 1 : FA_2016_RD1500_189_100_20160926_00242.jpg

Rodent burrows on landside slope of the levee. Estimated more than 2 cub.ft of soil got out. Fall 2016.

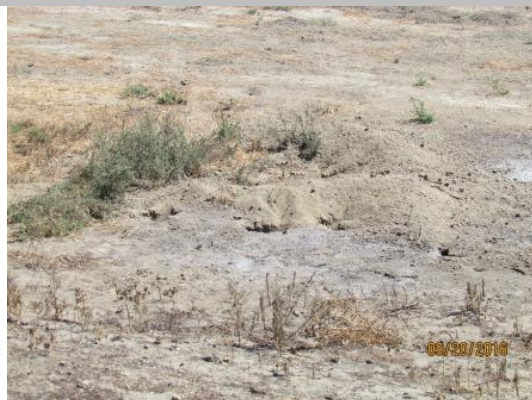
Photo 1 of 1 : FA_2016_RD1500_189_104_20160926_00253.jpg

More than 2 cu.ft. of soil was observed around burrows on LS slope of the levee. Fall 2016.

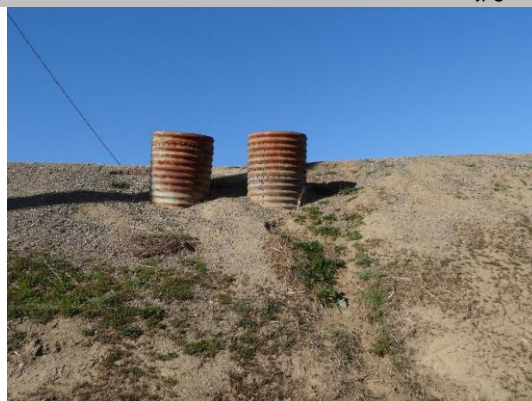
Photo 2 of 2 : UCIP_FA_2016_50194_51833.jpg

LS view: CMPs with leaky siphon breakers. Slope erosion and excessive vegetation on levee slope.

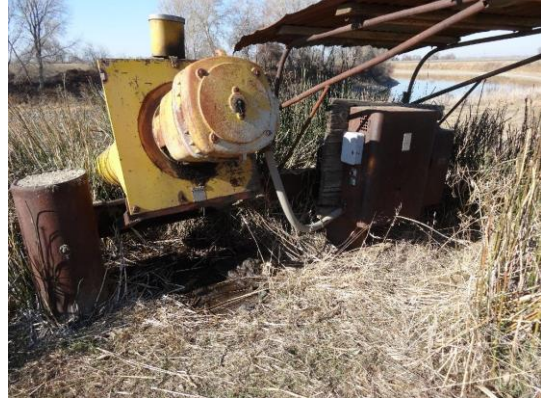
Photo 1 of 2 : UCIP_FA_2016_50193_51827.jpg

WS view: leaky slant pump on levee berm.

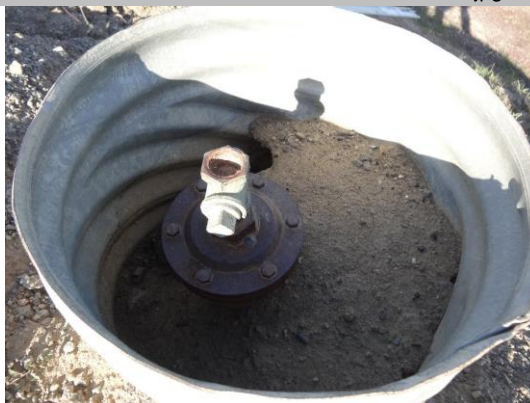
Photo 2 of 2 : UCIP_FA_2016_28144_51811.jpg

LS view: obstructed and leaked pressure breaker in CMP on levee slope.
